**Failure Analysis, Cadmium Brush Plate Qualification and
Salt Fog Testing of the AH-64 Shock Strut Mount,
P/N 7-311113409**

ARL-TR-2870

November 2002

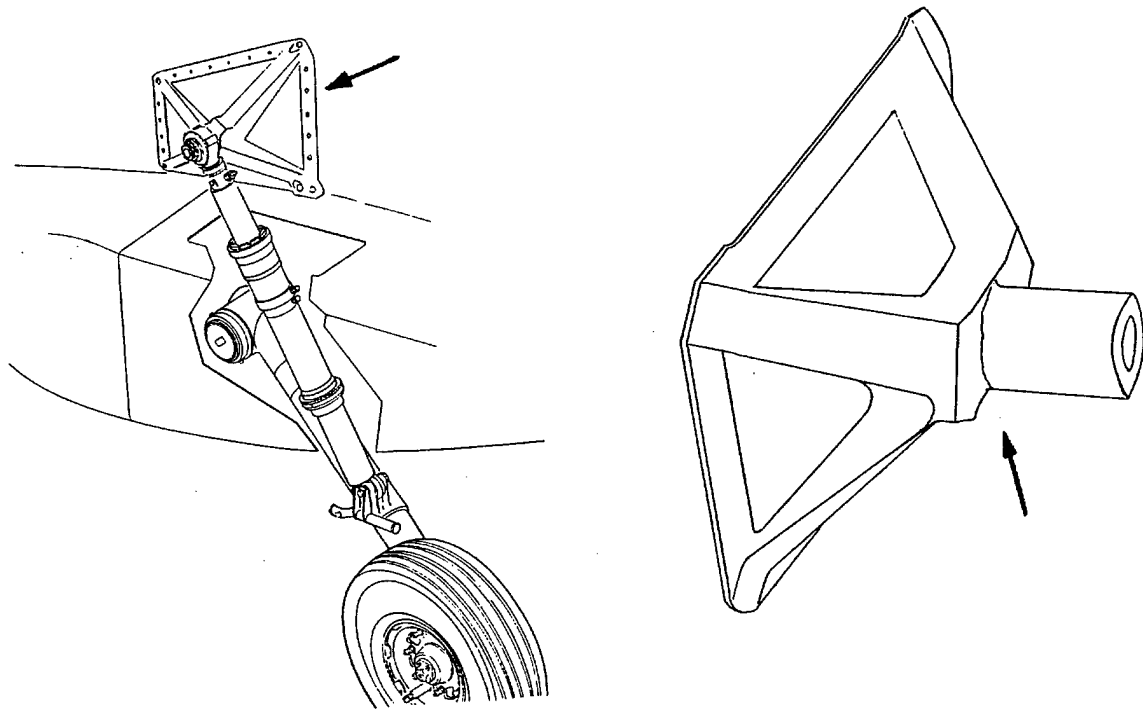
Figure 1. Schematic of the strut mount attached to the helicopter and the location of failure.

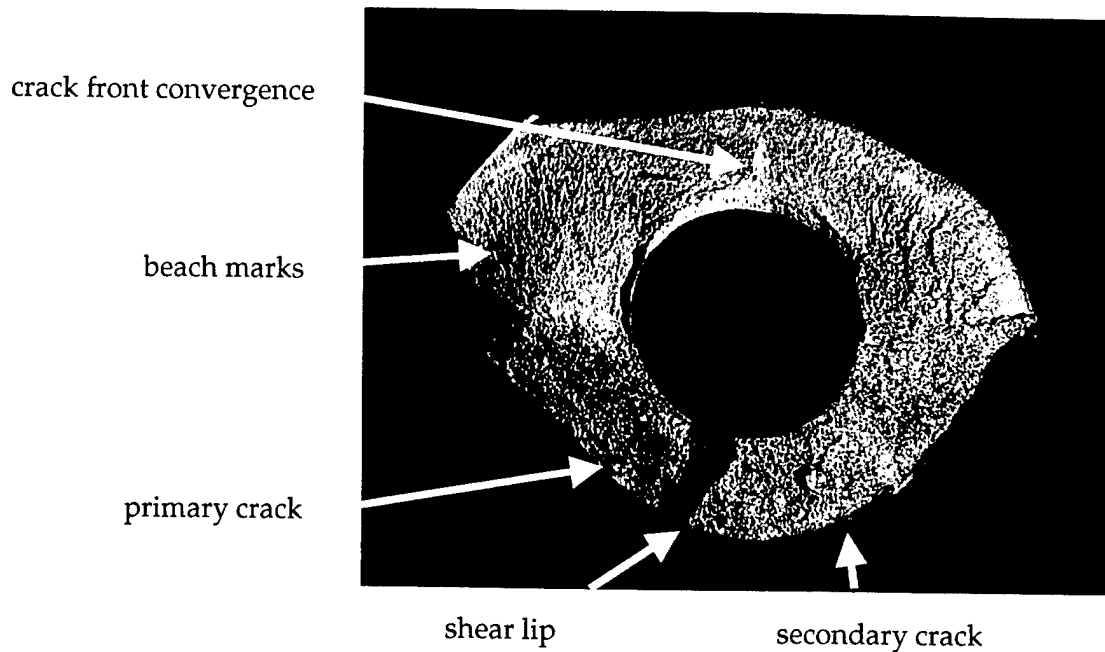
Figure 3. The fracture surface using oblique lighting. Note the shear lip separating the primary and secondary cracks, as well as the beach marks (mag. $\sim 1.4\times$).

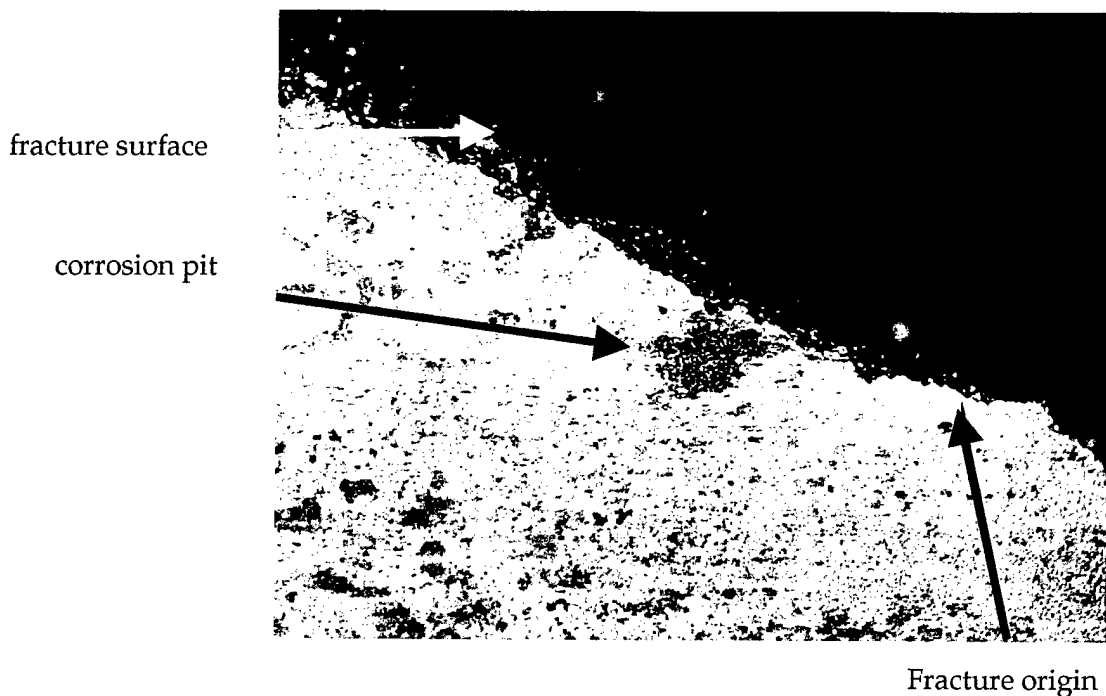
Figure 8. Corrosion pits adjacent to the primary origin (mag. 10 \times).

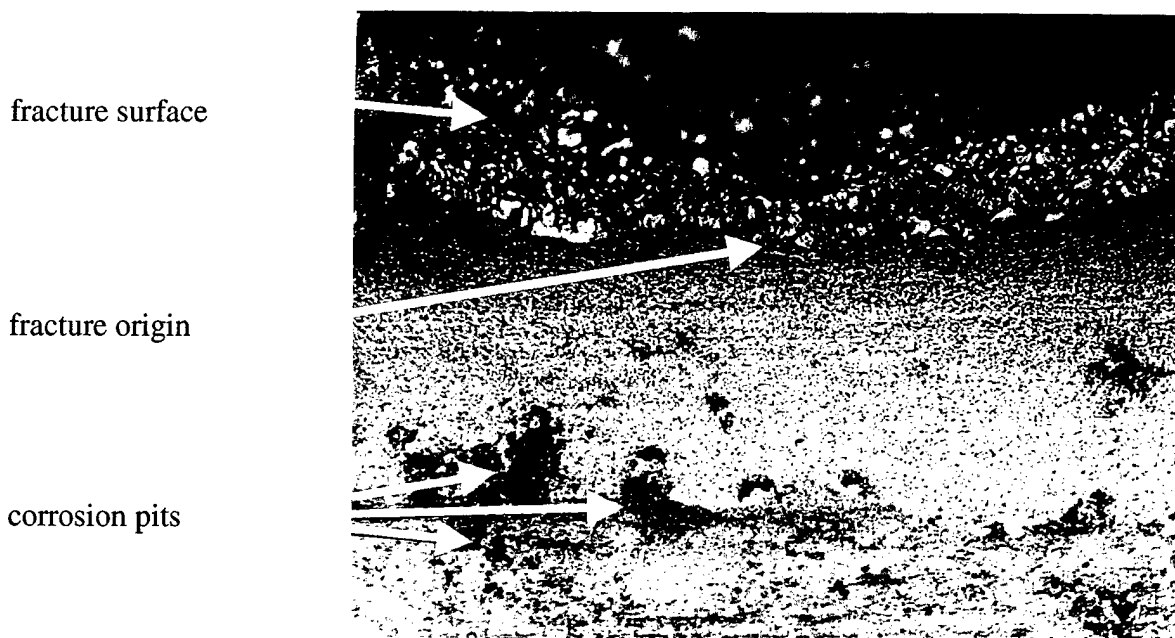
Figure 9. Corrosion pits adjacent to the secondary origin (mag. 10 \times).

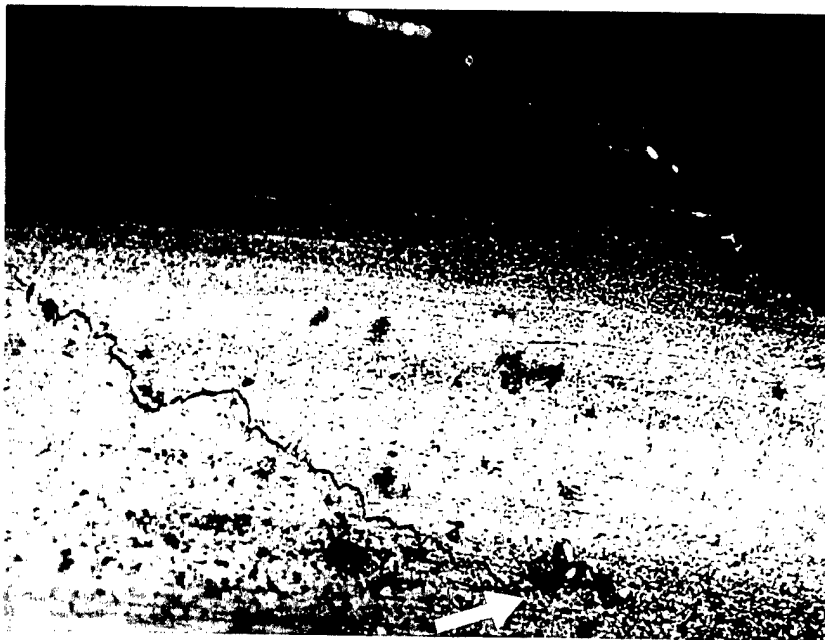
region. Also observed was a competing crack that was adjacent to the primary origin. Figure 11 shows the intergranular nature of this crack. There was also evidence of intergranular attack along this crack path. It was difficult to discern the exact location of the fracture origins; however, based upon the heavy corrosion in certain areas on both the primary and secondary crack surfaces, the general location of the origins was surmised.

Figure 11. Competing crack path adjacent to primary fracture surface. Note the intergranular nature of the crack, as well as the region of intergranular attack (mag. 15 \times).

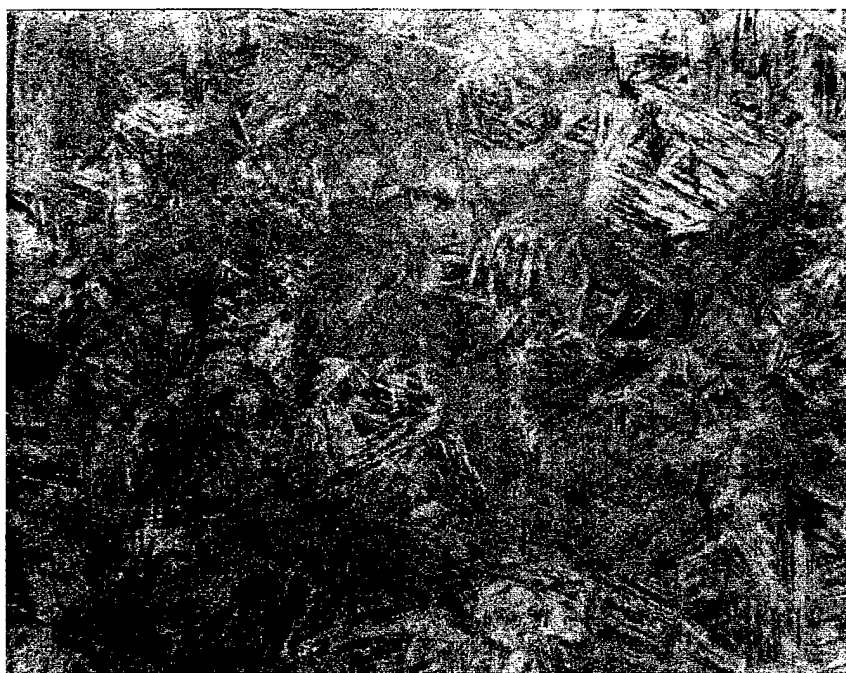
Figure 12. Microstructure of the material showing aged, low-carbon martensite in the longitudinal direction. Marble's Reagent (mag. 50×).

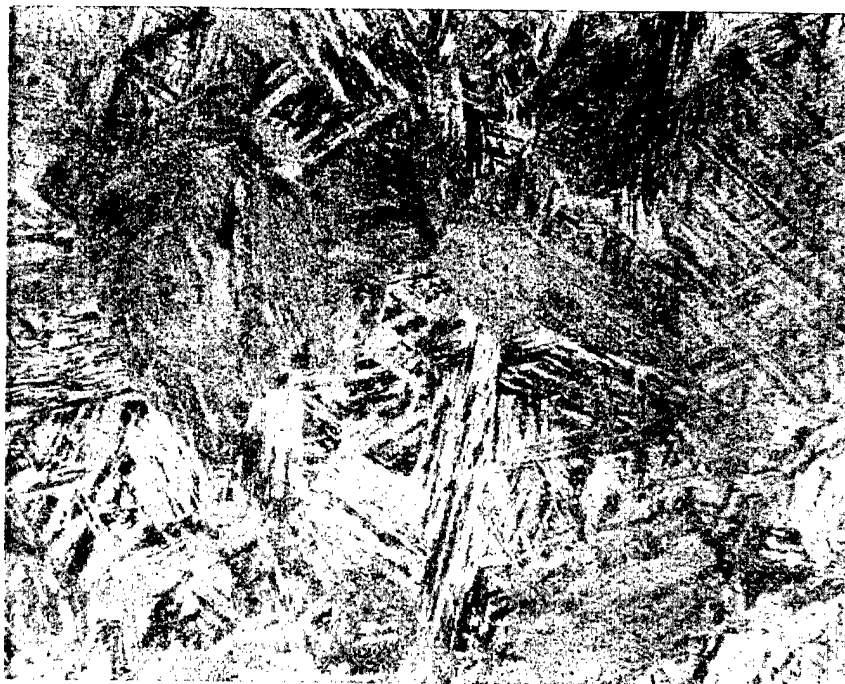
Figure 13. Microstructure similar to that in Figure 12 shown at higher magnification and in the transverse direction. Marble's Reagent (mag. 100 \times).

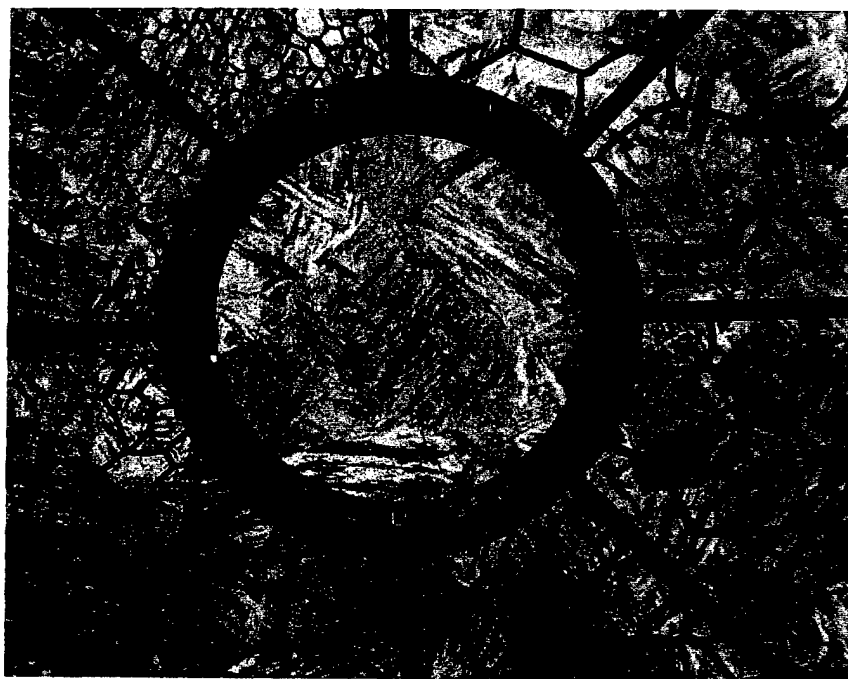
between nos. 2 and 3 at 100 \times magnification using the ASTM E112 charts over Figure 12. To verify this, a photomicrograph was taken using a grain size reticle, as shown in Figure 14. Again, the size was between nos. 2 and 3. The ASTM E112 charts indicate that the nominal diameter of the average grain is between 0.005 and 0.007 in, respectively for a grain size of nos. 3 and 2. A photomicrograph was subsequently taken of this structure at 100 \times , using an incremented reticle (Figure 15). As shown, the grain appear to have diameters ranging from 0.005–0.01 in, which correlated to the previous measurements. Subsequently, the intergranular fracture surface shown in Figure 18 (also see section 2.8) was also examined for grain size using the ASTM E112 “Fracture Grain Size” method. This technique is typically used for high-hardness, brittle steels with a predominantly martensitic structure, such as tool steels, high-carbon steels and martensitic stainless steels, and should be done with the specimen in the as-quenched or lightly tempered condition. Even though the Maraging 300 steel is a low-carbon alloy, the results obtained compared favorably to those from the other three methods. From Figure 18, the grain size ranged from ~100–200 μm , which correlated to a range of 0.004–0.008 in.

Figure 14. Microstructure of the material with grain size reticle overlay. The grain measured between nos. 2 and 3. Marble's Reagent (mag. 100 \times).

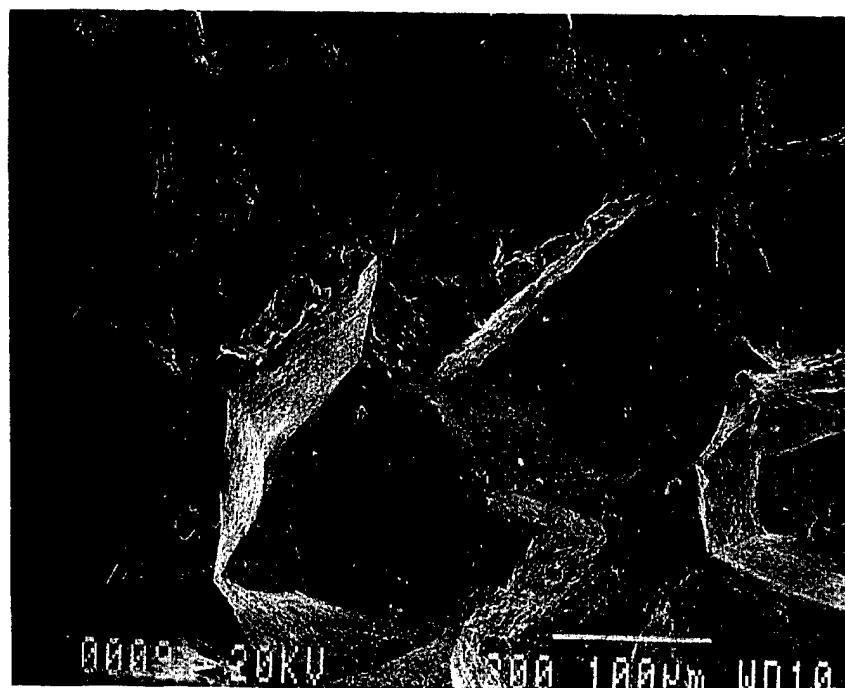
Figure 19. Magnified view of the intergranular morphology showing secondary cracking (mag. 200 \times).

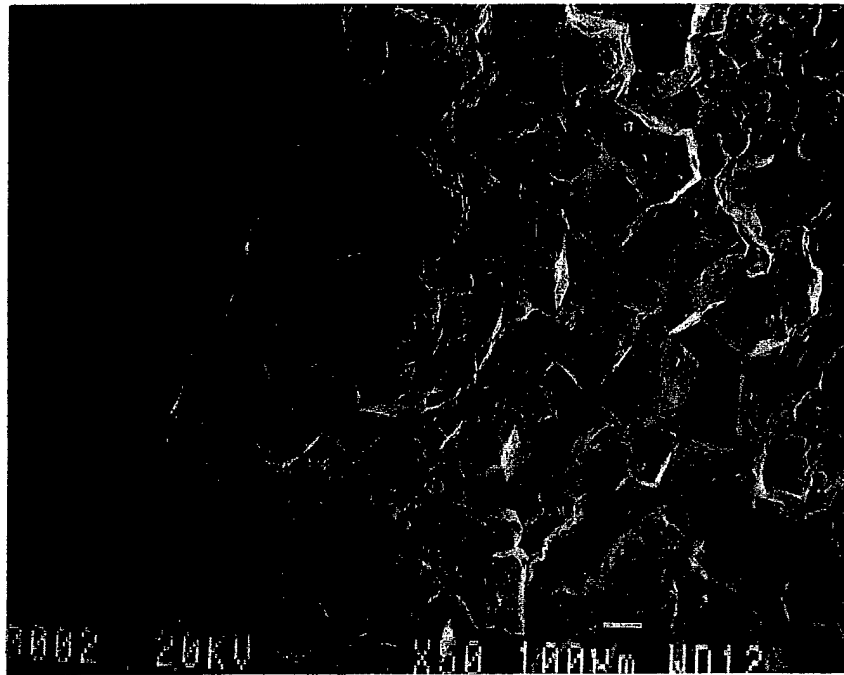
Figure 21. Interface between the secondary fracture surface and the shear lip (mag. 50×).

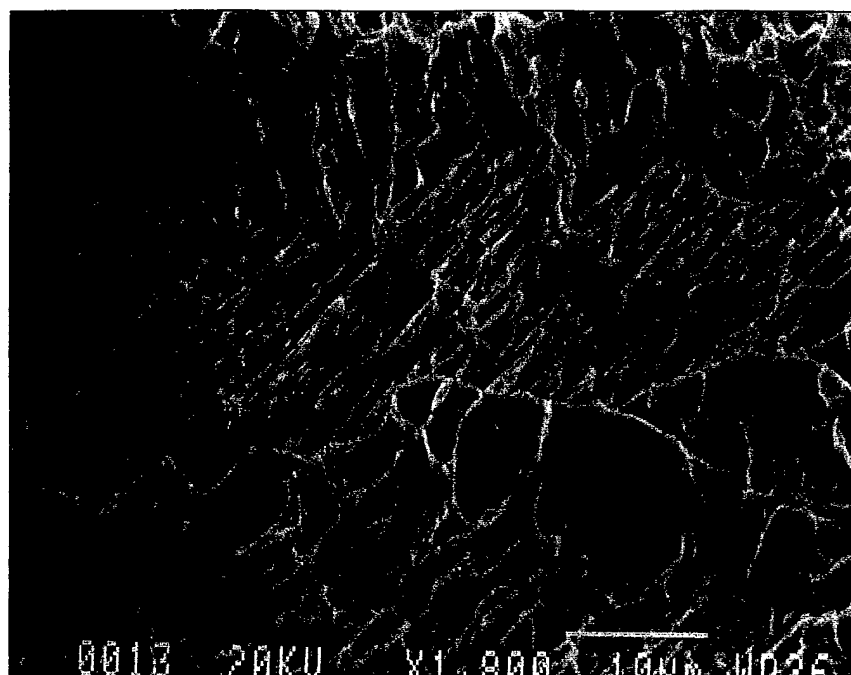
Figure 25. Transgranular/ductile morphology at higher magnification (mag. 1800×).

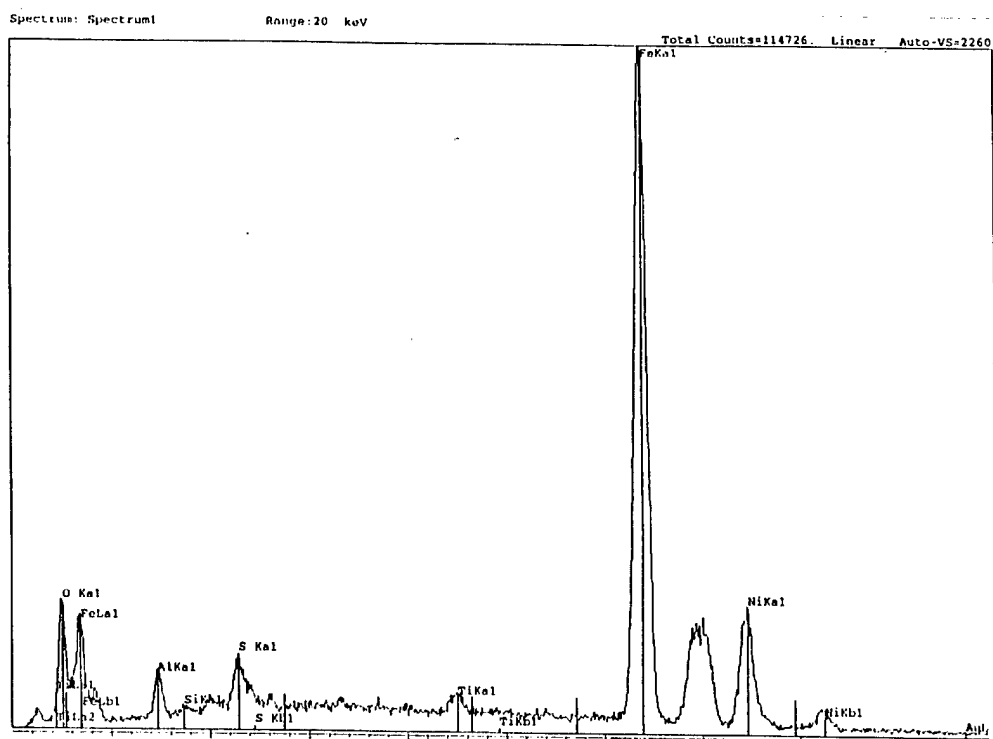
EDS was used in an effort to determine the presence of cadmium on the surface of the spindle. Exhaustive EDS spectra were generated along the spindle (and adjacent to the fracture origins), without revealing the presence of cadmium. Figure 26 is typical of the spectra generated in these regions. In contrast, analysis of the threaded region (where white, powdery corrosion products were noted) revealed the presence of cadmium as shown in Figure 27. The wear within the threads may not have been as severe as along the spindle, such that the cadmium was still somewhat intact. This was evidence that the part had been cadmium coated at one time.

Figure 26. Representative EDS spectra of the spindle of the failed part. No evidence of cadmium was noted along the spindle.

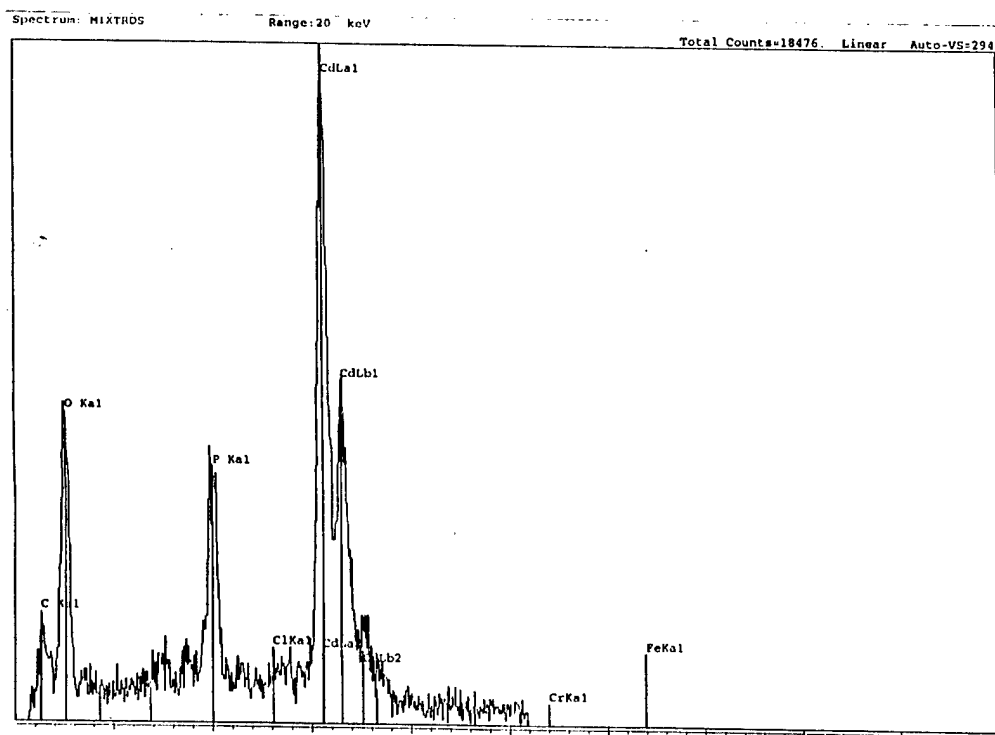
Figure 27. Representative EDS spectra within the threads of the failed part. Cadmium was noted within the threads.

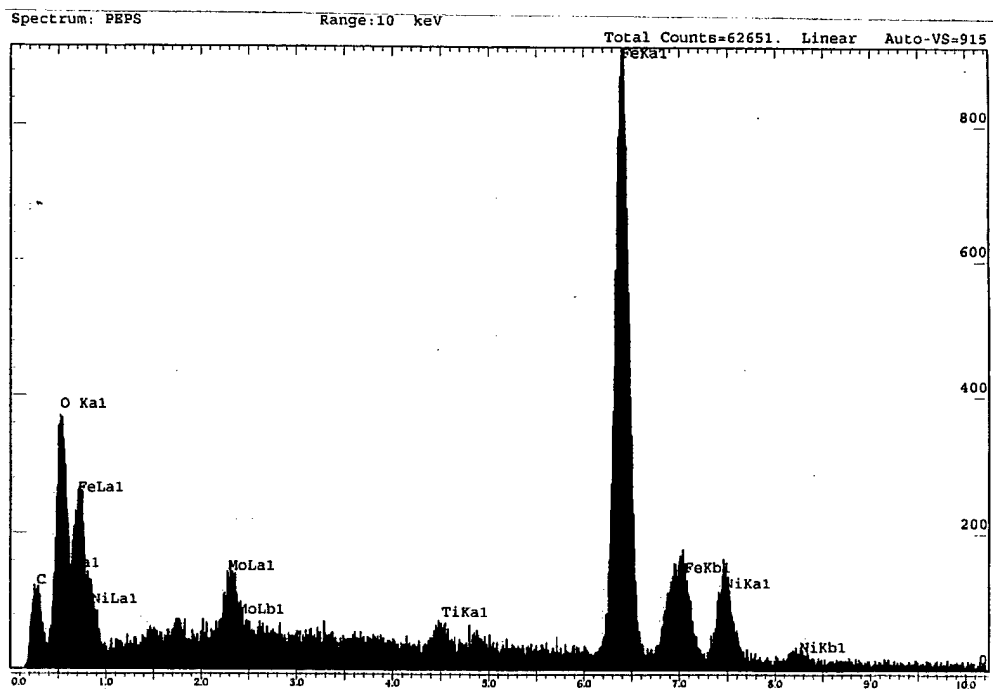
Figure 29. EDS spectra showing evidence of titanium within the precipitate shown in Figure 28. Other elements constitute the alloy.

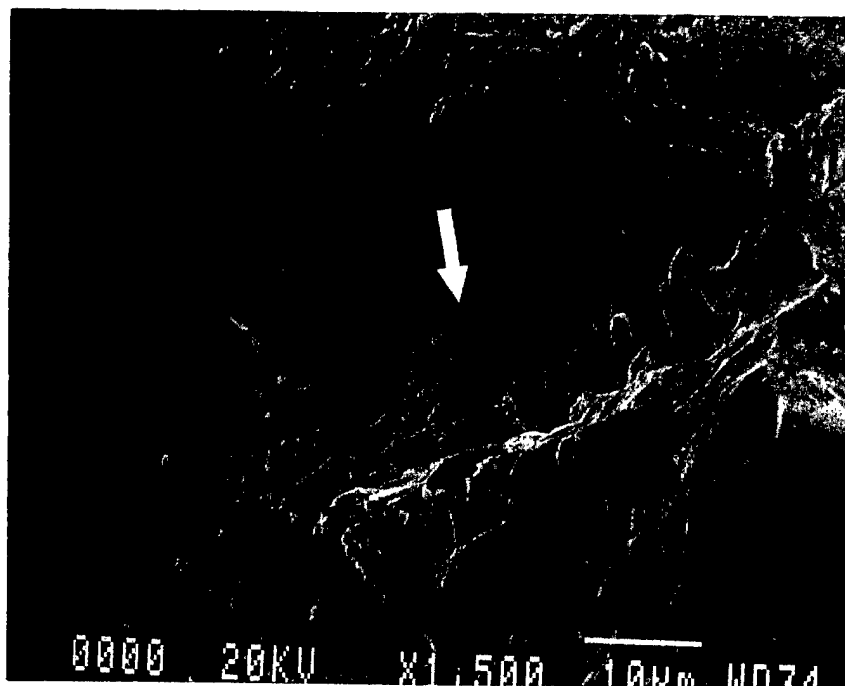
Figure 30. SEM micrograph of intergranular morphology of the primary fracture, showing the titanium-carbonitride precipitate that was examined using EDS (Figure 31) (mag. 1500 \times).

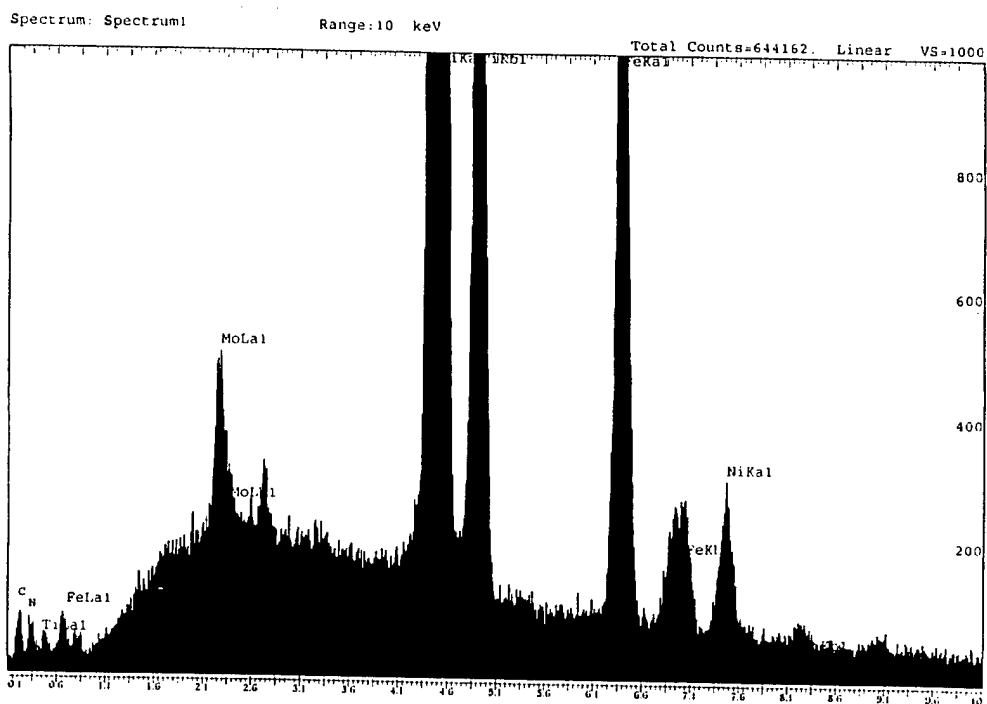
Figure 31. EDS spectra of the Ti (C, N) precipitate shown in Figure 30. Note the presence of titanium, carbon, and nitrogen, as well as the alloying elements.

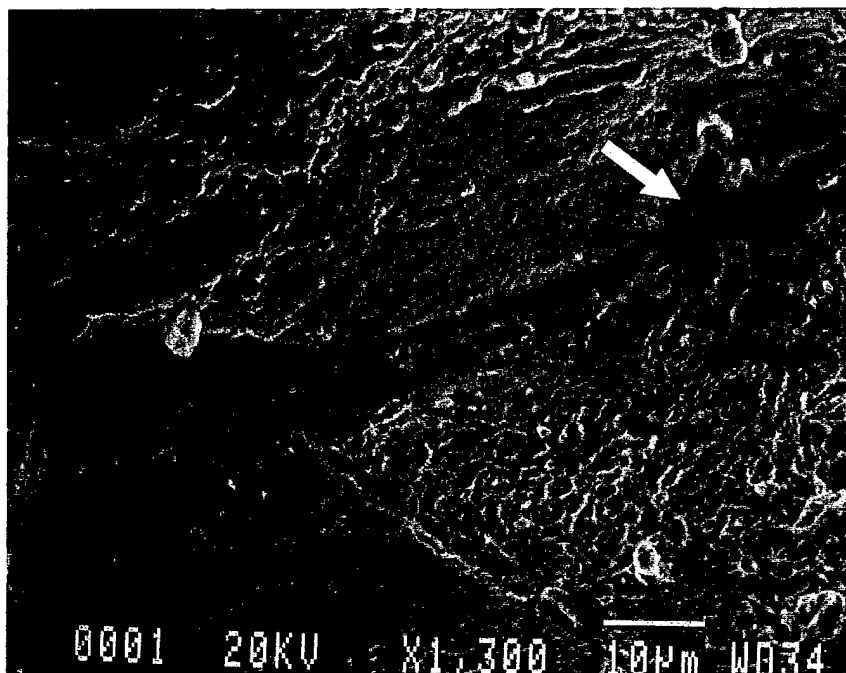
Figure 32. SEM micrograph of intergranular morphology of the primary fracture, showing another titanium-carbonitride precipitate (mag. 1300×).

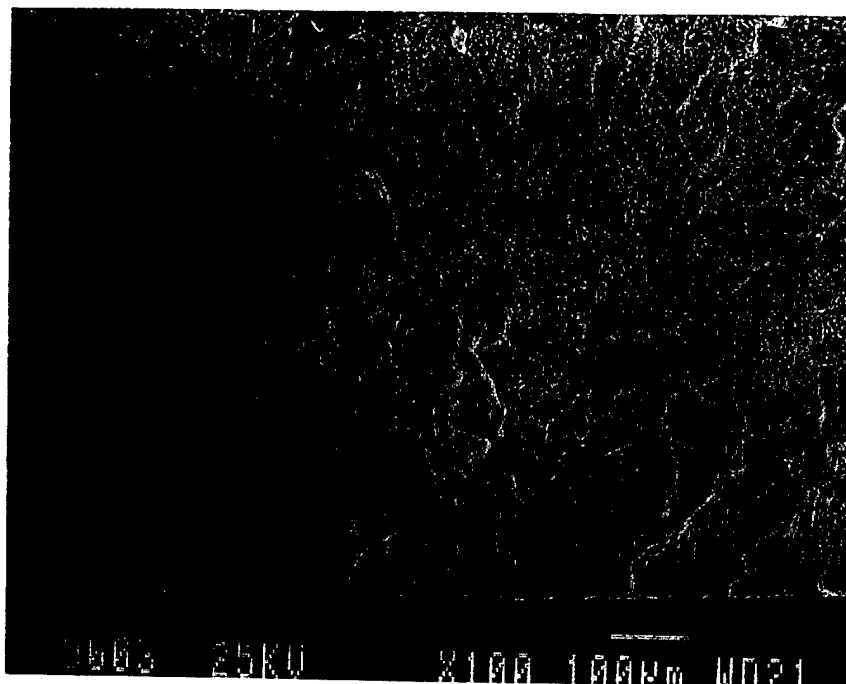
Figure C-12. Intergranular attack noted at origin no. 1 of Ft. Lewis specimen no. 3 (mag. 100 \times).

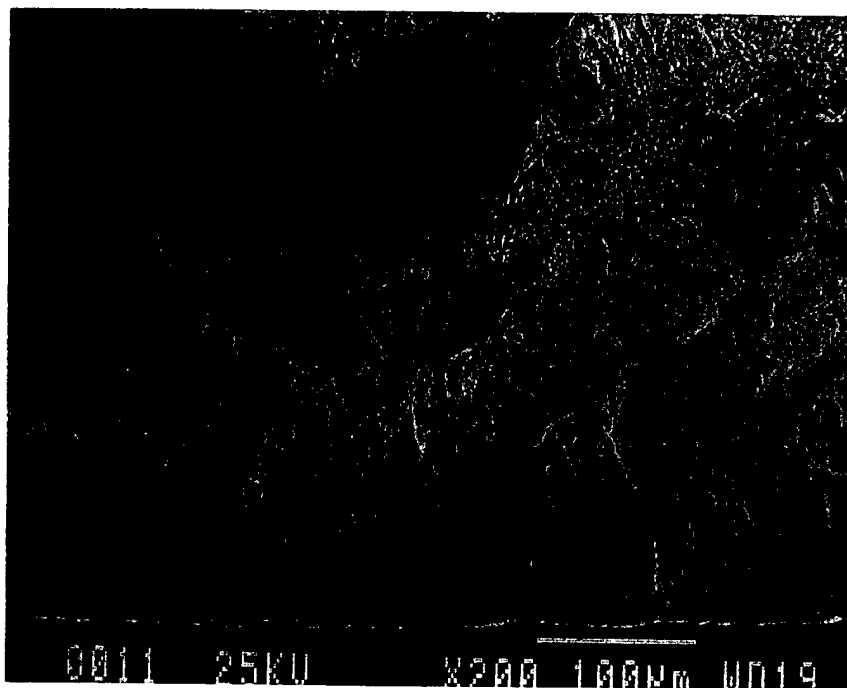
Figure C-16. Higher magnification of the intergranular attack noted at origin no. 2 (Figure C-13) of Ft. Lewis specimen no. 3 (mag. 200×).
